Hurricane Irma – Lessons Learned

Water, Water Everywhere

Presented By Christopher Matthews

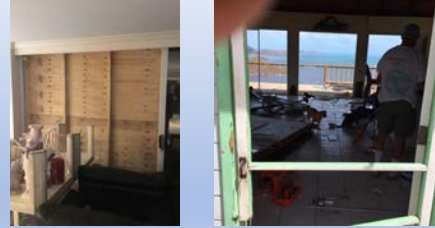
Non-Impact Systems were Heavily Damaged

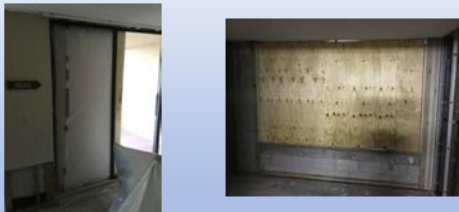
Non-Impact System Damage

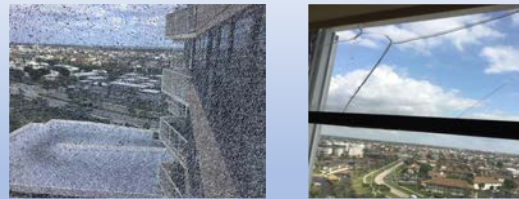
Non-Impact System Damage

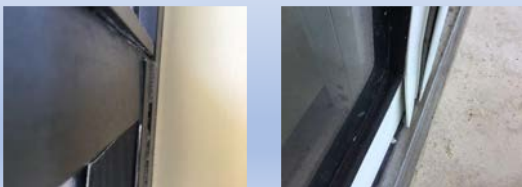
Impact Systems also Sustained Damage

- But in virtually all cases these did not blow out and the envelope was not breached

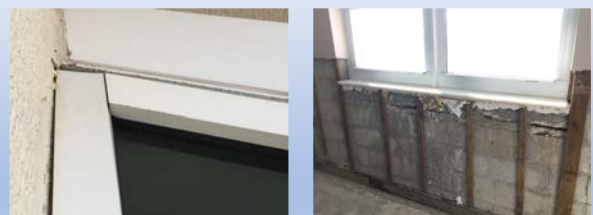
Impact System Damage

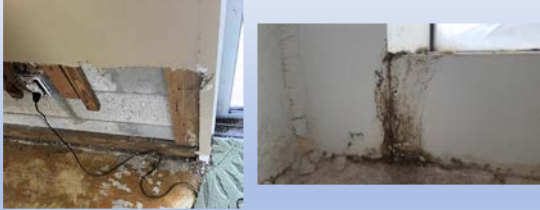
Water Leakage was Widespread in All Areas
